Ballistic Testing Services

Report Number: BTR-02-19-2010-Project Summary

Project Summary

Type of Products to be tested: Series 200B Wall Assembly
 Test Specimen Sample sizes: 48 x 60 x 5.3 inches
 Need the Tests performed by: February 25, 2010

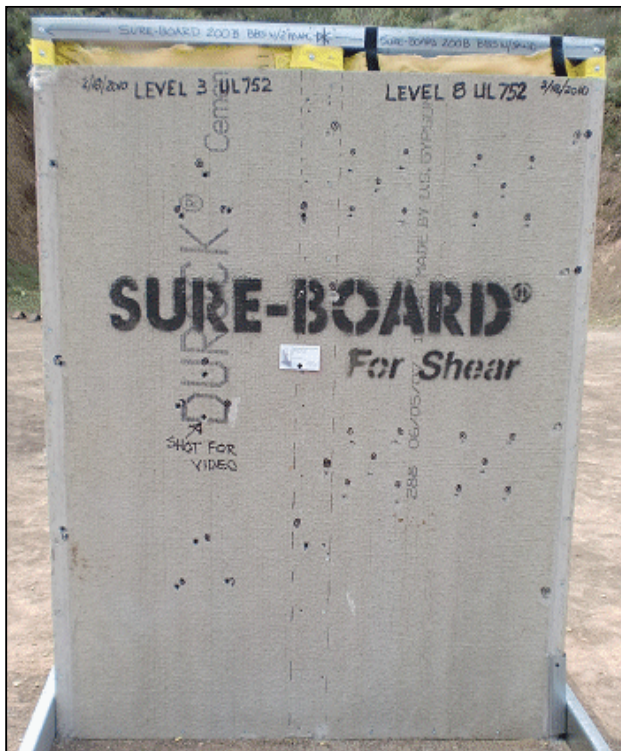
Photo 1 - Impact Side

This 48 x 60 Series 200B Wall Assembly was subjected to both UL752 Level 3 and Level 8 ballistic tests. The sample was divided vertically into two 24 inch wide sections separated by the wall's center-line structural support member. The left side was used for the UL Level 3 tests and the right side was used for the UL Level 8 tests. Both of the two 24 inch wide vertical sections and shot patterns are shown in [Photo 1 - Impact Side](#).

The Series 200B Wall Assembly passed all of the UL tests except for Tests #14 and 22. In these two single shot tests, the projectiles completely penetrated the wall within 1/2 inch distance of the vertical structural support members. This region is referred to as the "seam" in the table of results shown on page 1.

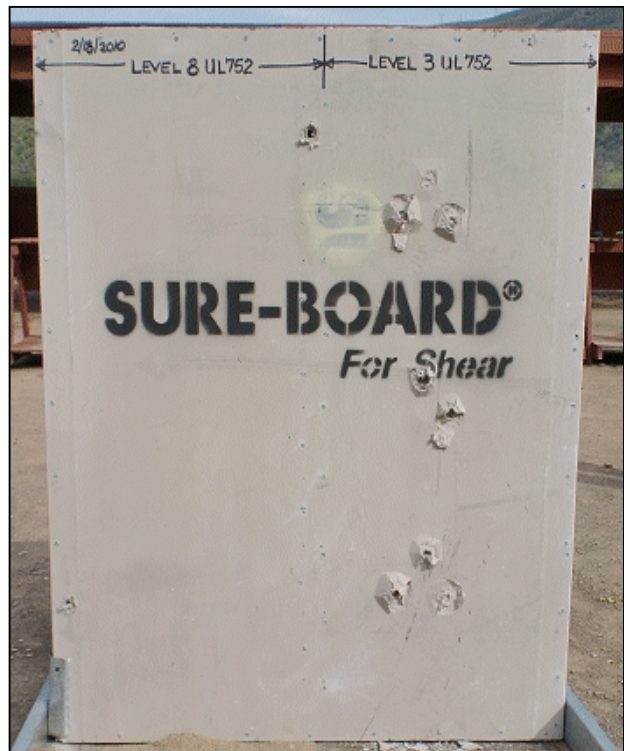
Photo 2 - Rear Side

In [Photo 2 - Rear Side](#), the three 3-shot patterns shown are not complete projectile penetration holes. They are bulges in the drywall surface caused by the projectile impacts from the other side. The powder-like spall ejected off the rear surface appeared to be lite and did not penetrate the 0.125 inch thick corrugated cardboard witness plate.
